MORTAR BEES

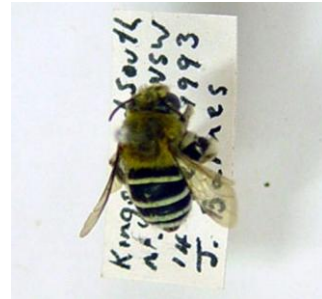
They prefer to work in the softer mortar mixes and can cause significant structural damage. Removing mortar from the joints of brickwork will enable moisture to enter the wall cavity and can cause some areas of collapse of brickwork when the damage is advanced.

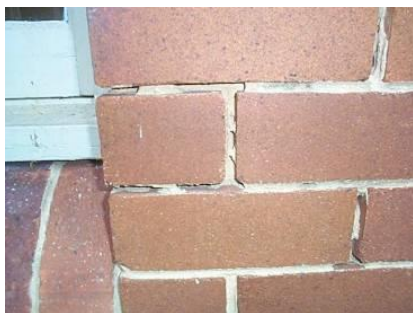
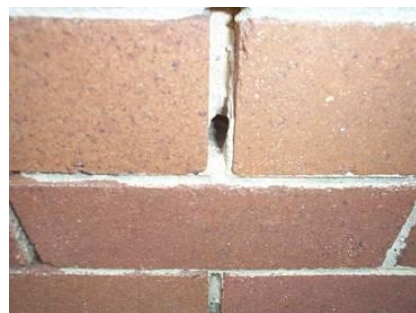
These pictures illustrate the damage by Mortar Bees, the have excavated the mortar from the joints of the bricks.

It would appear the when the Mortar Bee attack is advanced then the natural erosion of mortar from the brick joints in the immediate area will also increase.

To repair Mortar Bee damage it is recommended to point the mortar joints of the brickwork with a new mortar that may contain a higher percentage of cement, this will make the mortar too hard for the Mortar Bee to effectively remove with its hind legs.

Mortar Bee damage should be repaired immediately, once a single brick is loose then adjoining bricks can easily loosen; when a large area of brickwork is loose the immediate structure may fail.
