## MORTAR BEES

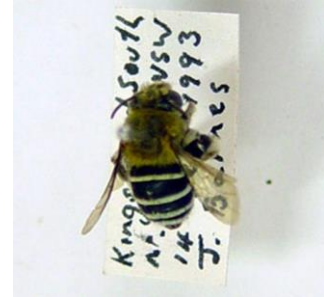
They prefer to work in the softer mortar mixes and can cause significant structural damage. Removing mortar from the joints of brickwork will enable moisture to enter the wall cavity and can cause some areas of collapse of brickwork when the damage is advanced.

To repair Mortar Bee damage it is recommended to point the mortar joints of the brickwork with a new mortar that may contain a higher percentage of cement, this will make the mortar too hard for the Mortar Bee to effectively remove with its hind legs.

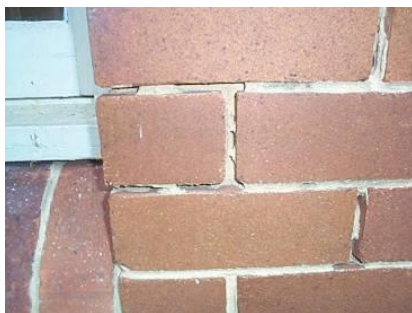
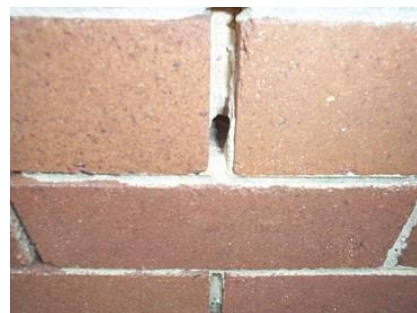
These pictures illustrate the damage by Mortar Bees, they have excavated the mortar from the joints of the bricks.

It would appear that when the Mortar Bee attack is advanced then the natural erosion of mortar from the brick joints in the immediate area will also increase.

Mortar Bee damage should be repaired immediately, once a single brick is loose then adjoining bricks can easily loosen, when a large area of brickwork is loose the immediate structure may fail.
