Common Timber Borers

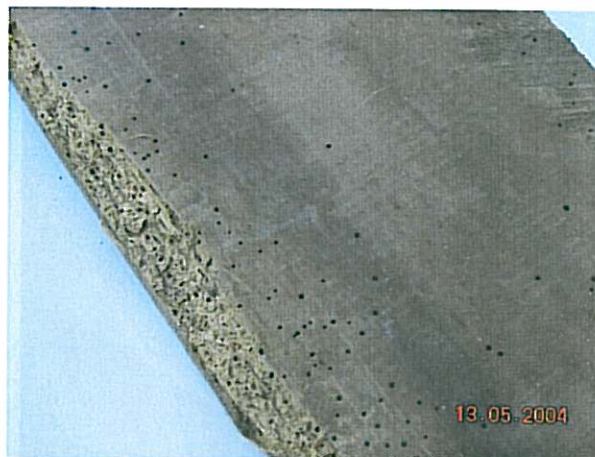
Anobium Borer Timber Damage

Commonly found in Baltic pine floors and cupboards and occasionally in radiata pine floorboards. Anobium borer does not attack hardwood timbers. The flight holes (1-2mm) resemble small nail holes which when sanded appear as squiggly lines on the surface. The larva makes the dust or frass that comes out of these holes; the frass appears grain like (when rubbed between your fingers it has a gritty feel). The frass is chewed wood fragments

The borer life cycle is approx 3 years from egg, lava, pupa to adult. The adult Anobium borer only lives a few weeks and after emerging from its exit hole (flight hole) in the timber it quickly finds a mate, to breed and lays eggs. The longest stage of the borer life cycle is spent as a grub or larva in the effected timber and it is this that causes structural damage to the timber. The larva stage is spent entirely in the wood and lasts not less than 2 years.

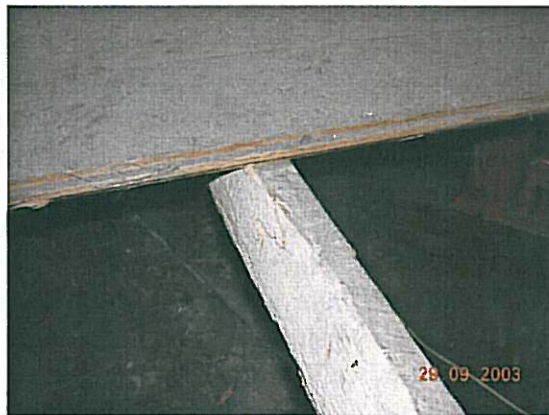
Lyctus Borer damage to floor joists

Lyctus borer is often found in the edge of timber framing, skirtings and architraves. The holes are pinhole size (very small) and the powder (frass) is very fine, almost like talcum powder, only a timber colour. This borer rarely attacks pines but is commonly found during renovations when framing is exposed, often by electrician when re-wiring in the roof space, in timber tile battens when replacing roofs or lifting roof tiles, and in subfloor timbers such as bearers and floorjoists when restumping. Exopest follows the CSIRO advice and does not recommend treatment for this borer, since the damage to timbers is generally decorative and non-structural. A tree consists of a centre core of wood known as heartwood; a thinner layer known as sapwood, which is located, just beneath the bark. When timber is milled, up to 25% sapwood can be present within that timber, and since 75% of the effected piece is heartwood, it remains structurally sound and is not considered necessary to treat.
