## Common Timber Borer

### **Anobium borer – Anobium punctatum (furniture beetle)** Life cycle (1-3 years)

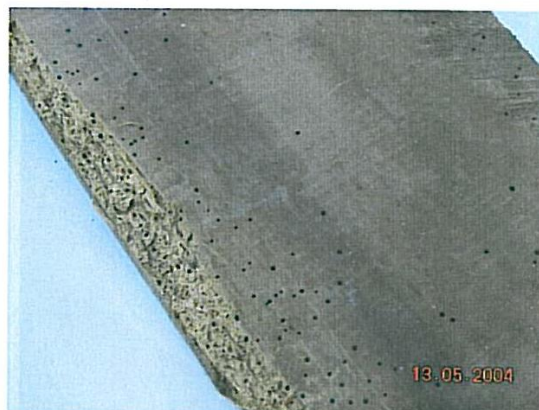
Commonly found in Baltic pine floors and cupboards and occasionally in radiata pine floorboards. Anobium borer does not attack hardwood timbers. The flight holes (1 – 2mm) resemble small nail holes which when sanded appear as squiggly lines on the surface. The larva makes the dust or frass that comes out of these holes; the frass appears grain like (when rubbed between your fingers it has a gritty feel). The frass is chewed wood fragments.

Anobium Borer Timber Damage

Anobium borer only attack softwood timbers and since the majority of structural timbers are hardwood, structural damage is limited.

Treatment options include contacting Exopest for advice on treating softwood timbers, replacing timbers with hardwood, increasing ventilation and reducing moisture and dampness in subfloor spaces. Treatments include surface application using Boracol 200H or Perigen 500 to effected timbers. Ideally both sides of the infested timber are treated for optimal control.

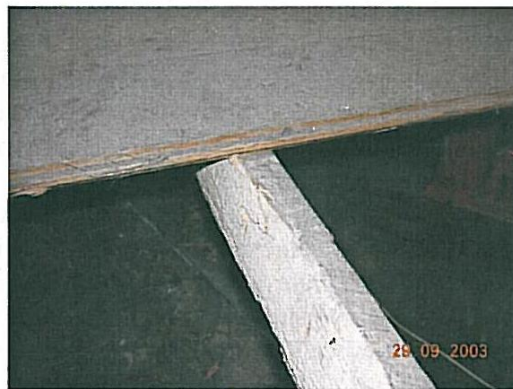
Lyctus borer is often found in the edge of timber framing, skirtings and architraves. The holes are pinhole size (very small) and the powder (frass) is very fine, almost like talcum powder, only a timber colour. This borer rarely attacks pines but is commonly found during renovations when framing is exposed, often by electrician when re wiring in the roof space, in timber tile battens when replacing roofs or lifting roof tiles, and in subfloor timbers such as bearers and floor joists when restumping. Exopest follows the CSIRO advice and does not recommend treatment for this borer, since the damage to timbers is generally decorative and non-structural. A tree consists of a centre core of wood known as heartwood; a thinner layer known as sapwood which is located, just beneath the bark. When timber is milled, up to 25% sapwood can be present within that timber and since 75% of the effected piece is heartwood, it remains structurally sound and is not considered necessary to treat.

Lyctus borer damage to floor joists
